Your Pump and Valve
Wear & Acid Protection Specialist
"Ziroflex Coating"

STANFRA

PROFILE

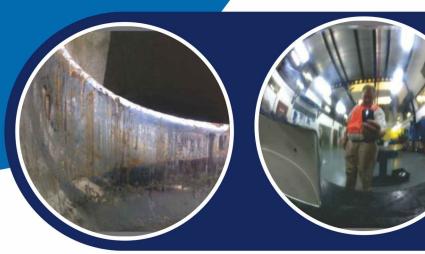
200mm Ball

Before and After

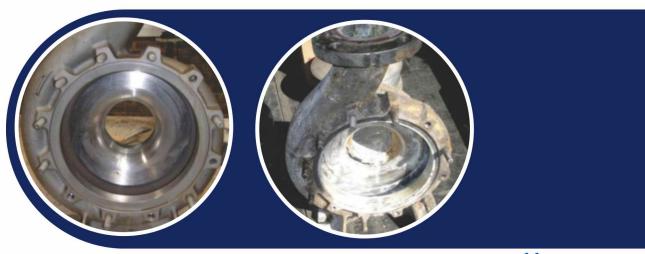
S/Steel Volute Casing

Rebuild

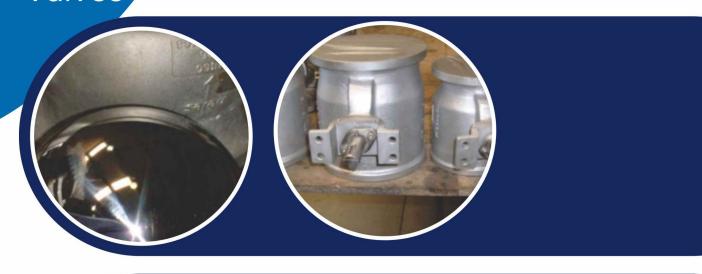
S/Steel Ball & Segment

Valves

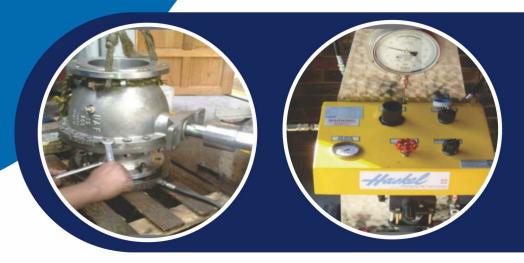
DN 200 Pocket Valve

Recondition

and Pressure Test

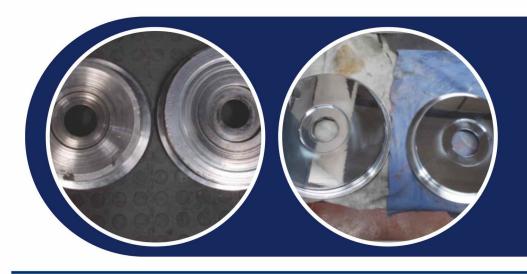
Backplates - Stuffing Boxes

Before and After

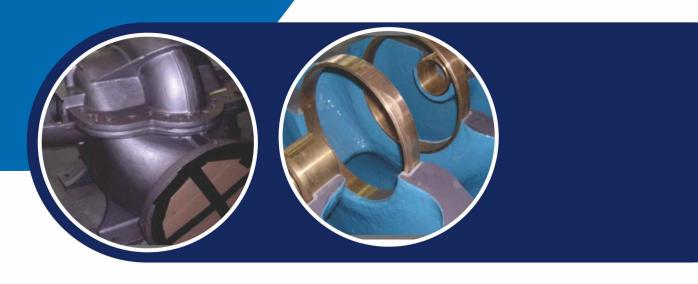
SDA 300 / 400 Envirotech Pump

Rebuild

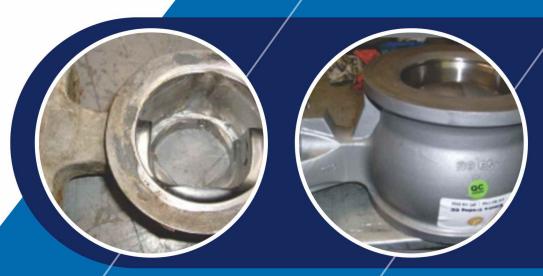
Segment Ball Valve

Before and After

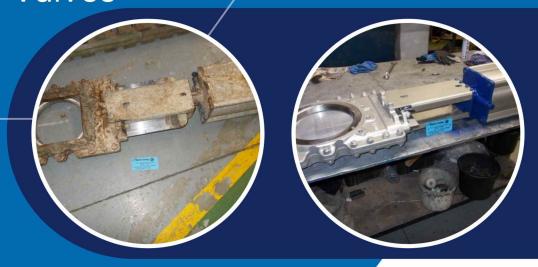
Reconditioned Knife Gate

Valves

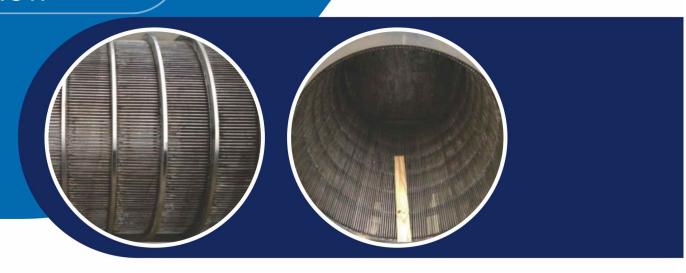
Manufacturing of Top Separator Basket

New

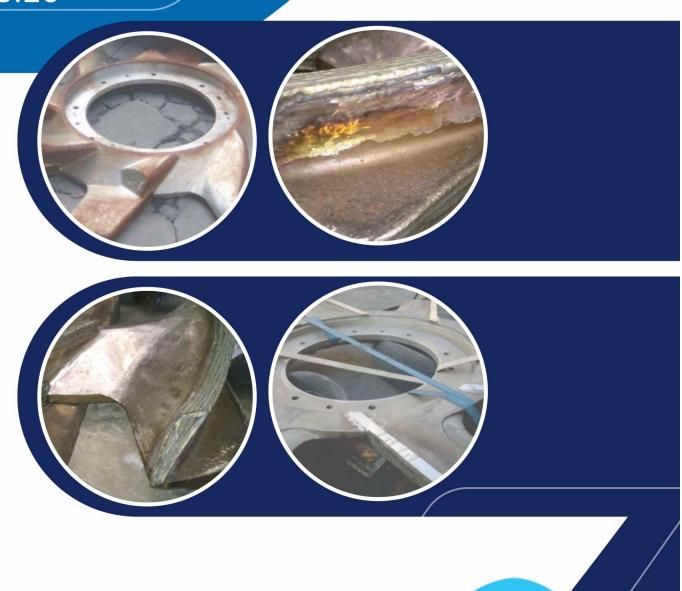
Reconditioning of Hydrapurge Rotor

63.25"

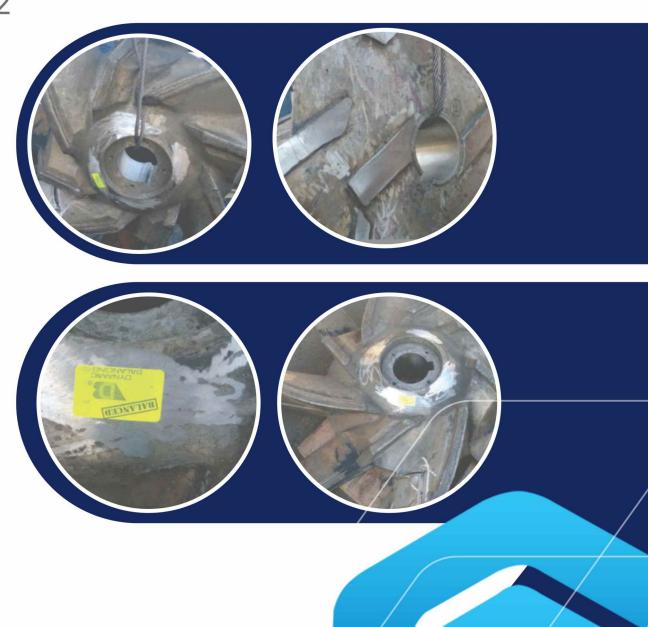
Reconditioning of Repulper Rotor

42"

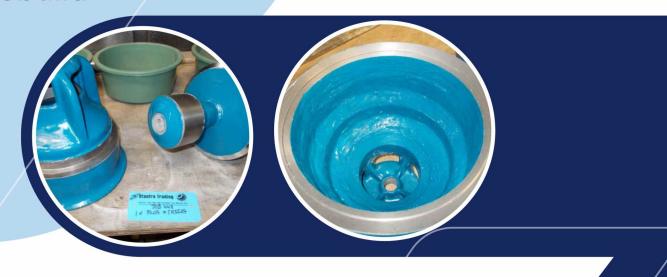
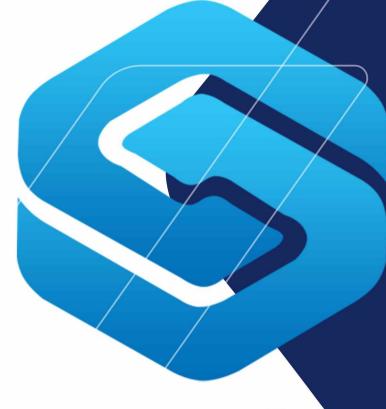
Coatings Epoxy Wear

Rebuild
